Alton Station Timber Footbridge

Structure Summary Report January 2017

Date 09 April 2015
Reference UA007705-19-ECV-MEM-HYD-1502 rev A01
From Toby Skeels
To Ian Grimes, Daniel Perez
Copies Richard Shimell, James Buckley, Tom Faith, Geoff Rowan
Subject Alton Station – Heritage Footbridge Condition Report

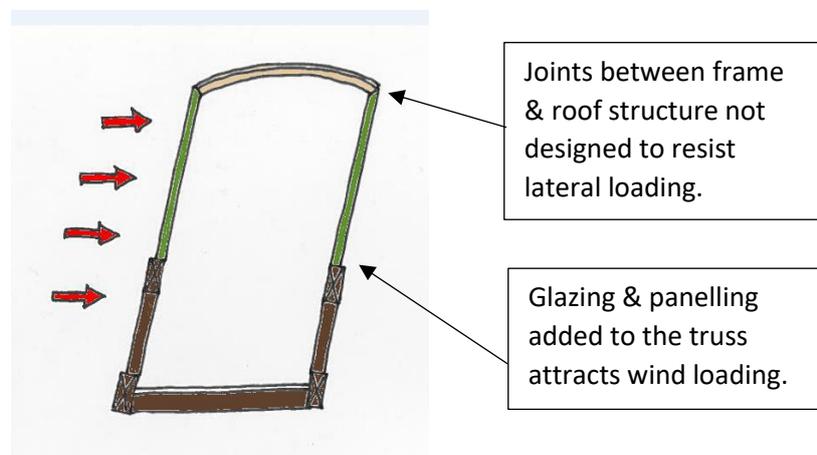
The main concern identified by Integral is the evident lack of rigidity/stiffness to resist lateral loading i.e. horizontal wind loading. It is evident by inspection that the connections between the deck/walkway and the trusses, plus the roof corner connections, are inadequate to resist the theoretical forces from wind on the bridge elevations. There is a lack of rigidity which results in excessive lateral movement and potential failure/collapse (see figure 8).

It would appear that a bridge designed and constructed as an 'open' sided structure has had subsequent modifications that has resulted in it being fully clad. As a consequence this has added lateral forces onto the structure for which the original structure has not been designed to resist.

Integral suggest that it would be practical to strengthen the overall structure to resist lateral forces by the introduction of new rigid steel frames within the footbridge (see figure 9).

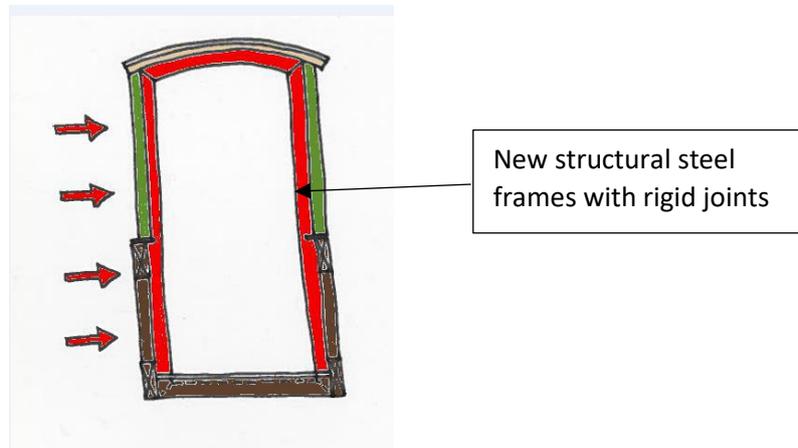
Figure 9 - Diagram of stiffening from the Integral report

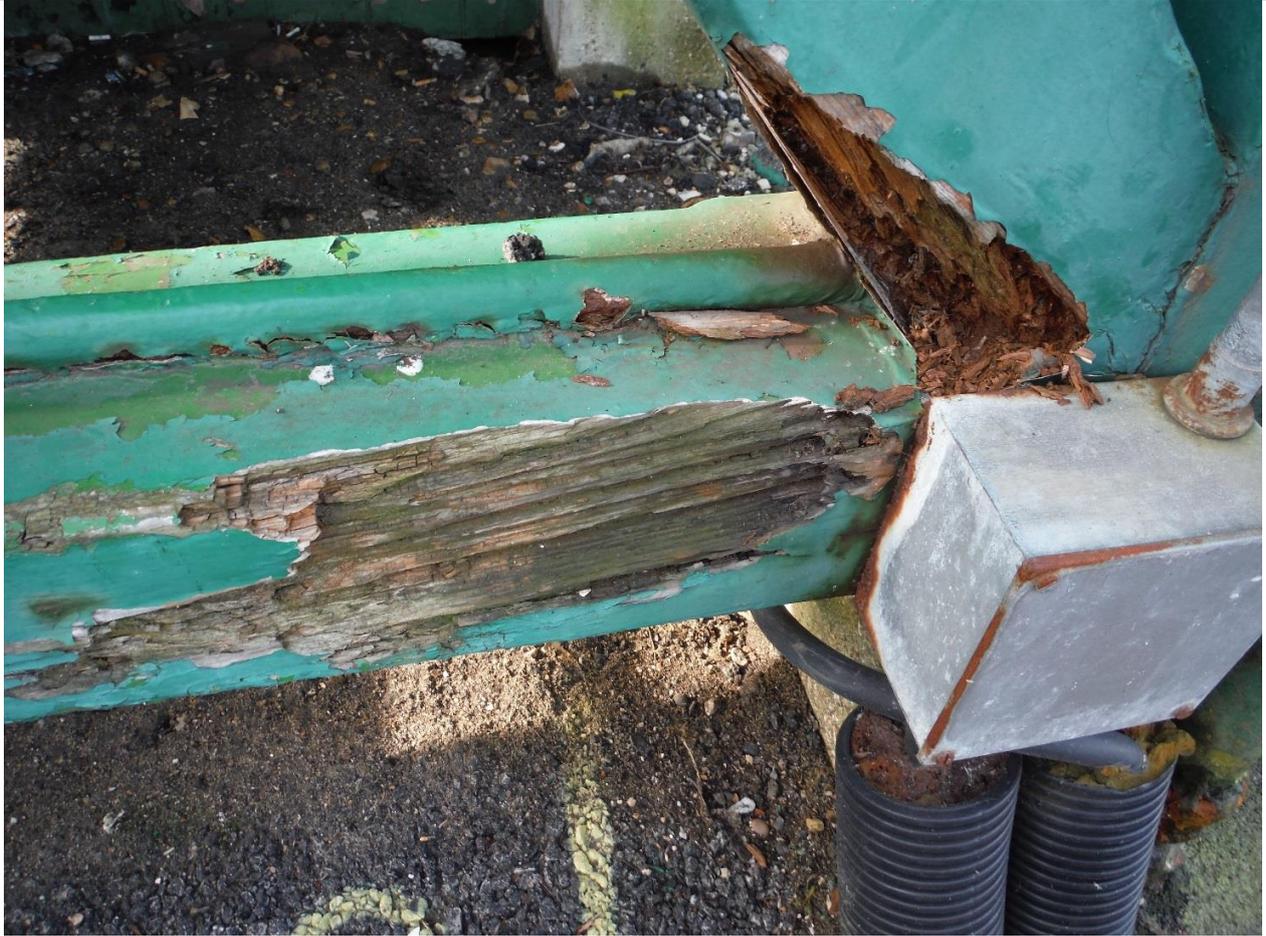
Photo 1: Wet rot to lower connection of 4 post support column diagonal brace (Platform 1)

Photo	Defect	Repair	Time frame for action
1	Wet rot causing loss of section	It is recommended that where rot (wet and dry) is present that specialist advice is sought to ensure appropriate remedial action is taken to agree a surface treatment is performed to prevent further section loss	3 Months
2	Dry rot causing loss of section	It is recommended that where rot (wet and dry) is present that specialist advice is sought to ensure appropriate remedial action is taken to agree a surface treatment is performed to prevent further section loss	3 Months
3	Dry rot causing loss of section	It is recommended that where rot (wet and dry) is present that specialist advice is sought to ensure appropriate remedial action is taken to agree a surface treatment is performed to prevent further section loss	3 Months
4	Minor spalling and corrosion of concrete base upstand reinforcement	Small concrete patch repair with associated preparation of area to be repaired.	To be monitored

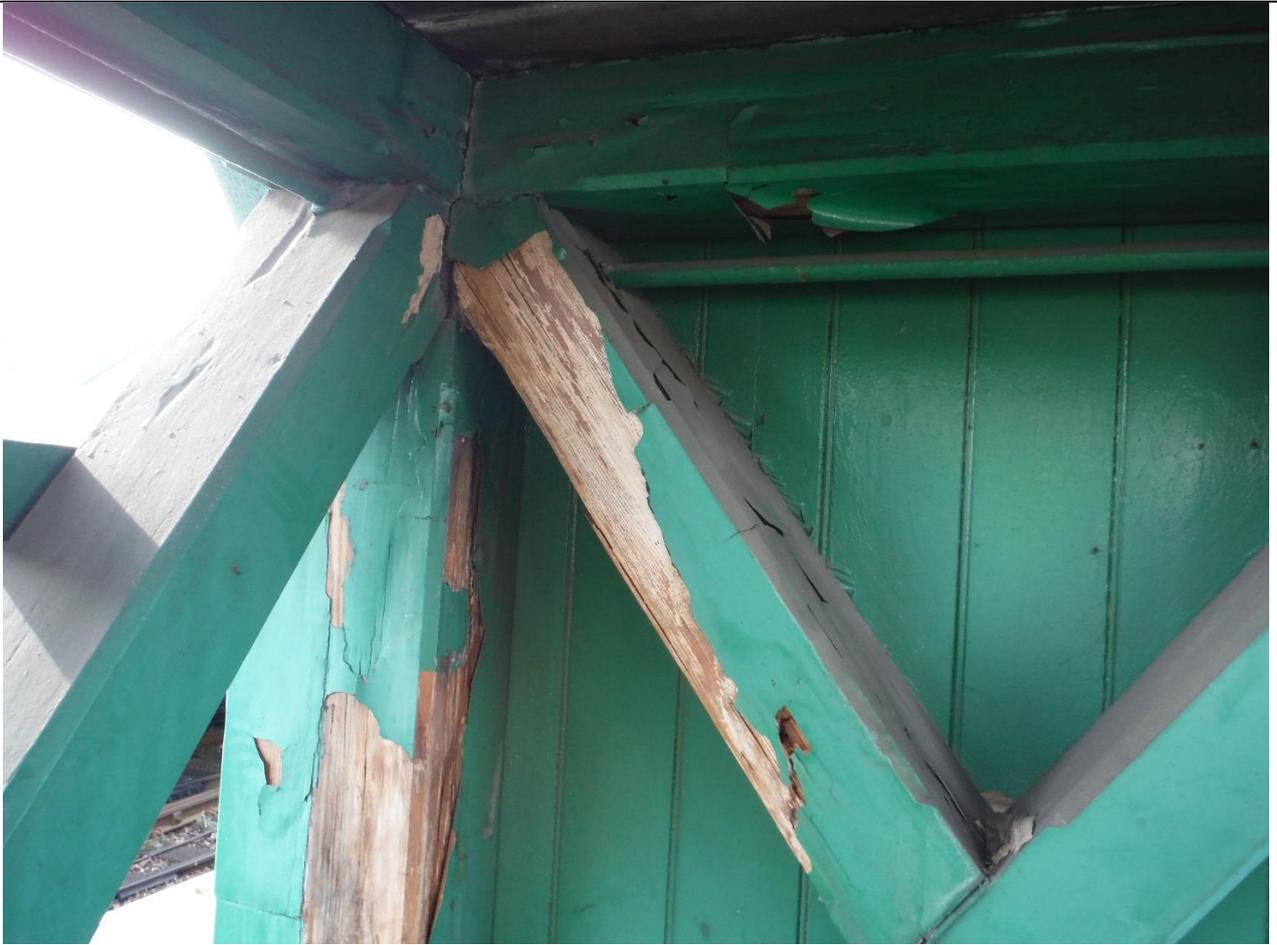
Photo 2: Dry rot to underside of 4 post support column diagonal brace (Platform 1)

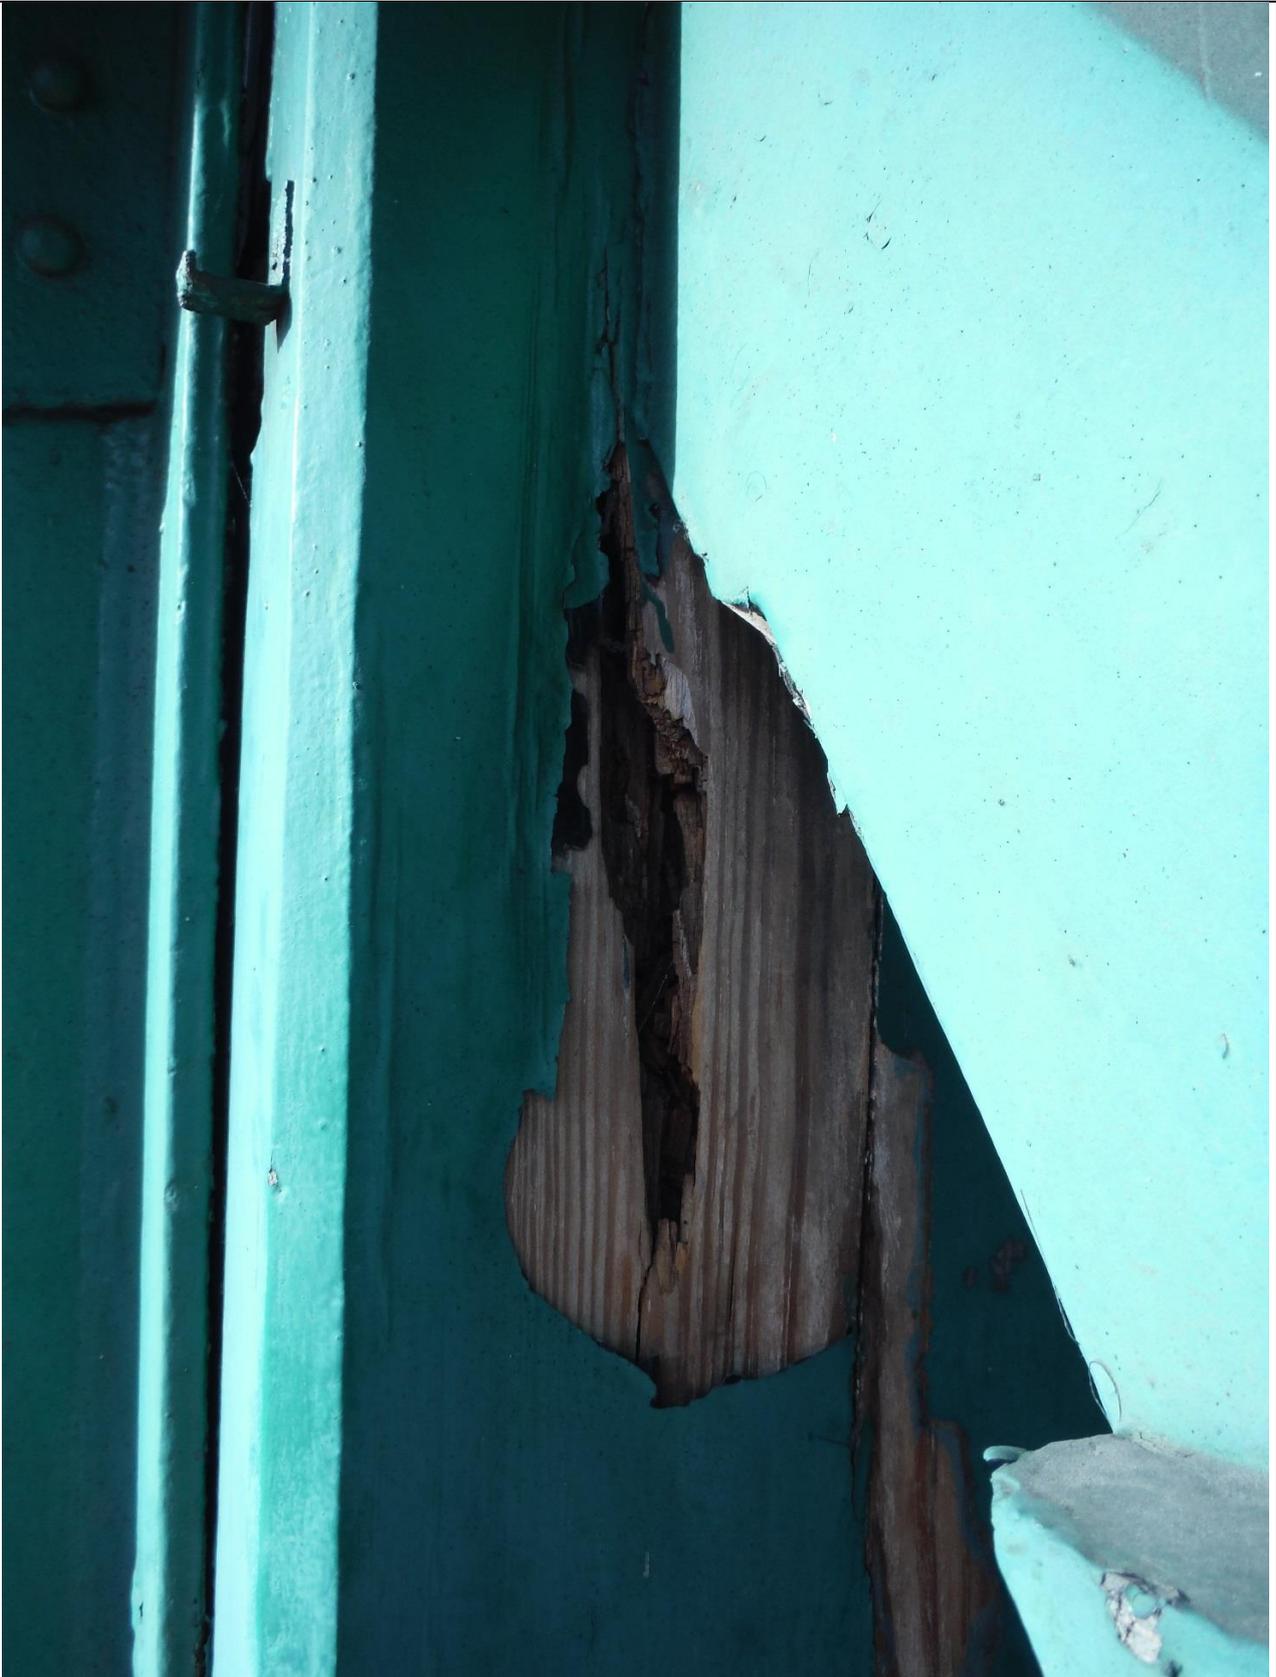
Photo 3: Dry rot to vertical face of 4 post support column diagonal brace (Platform 1)

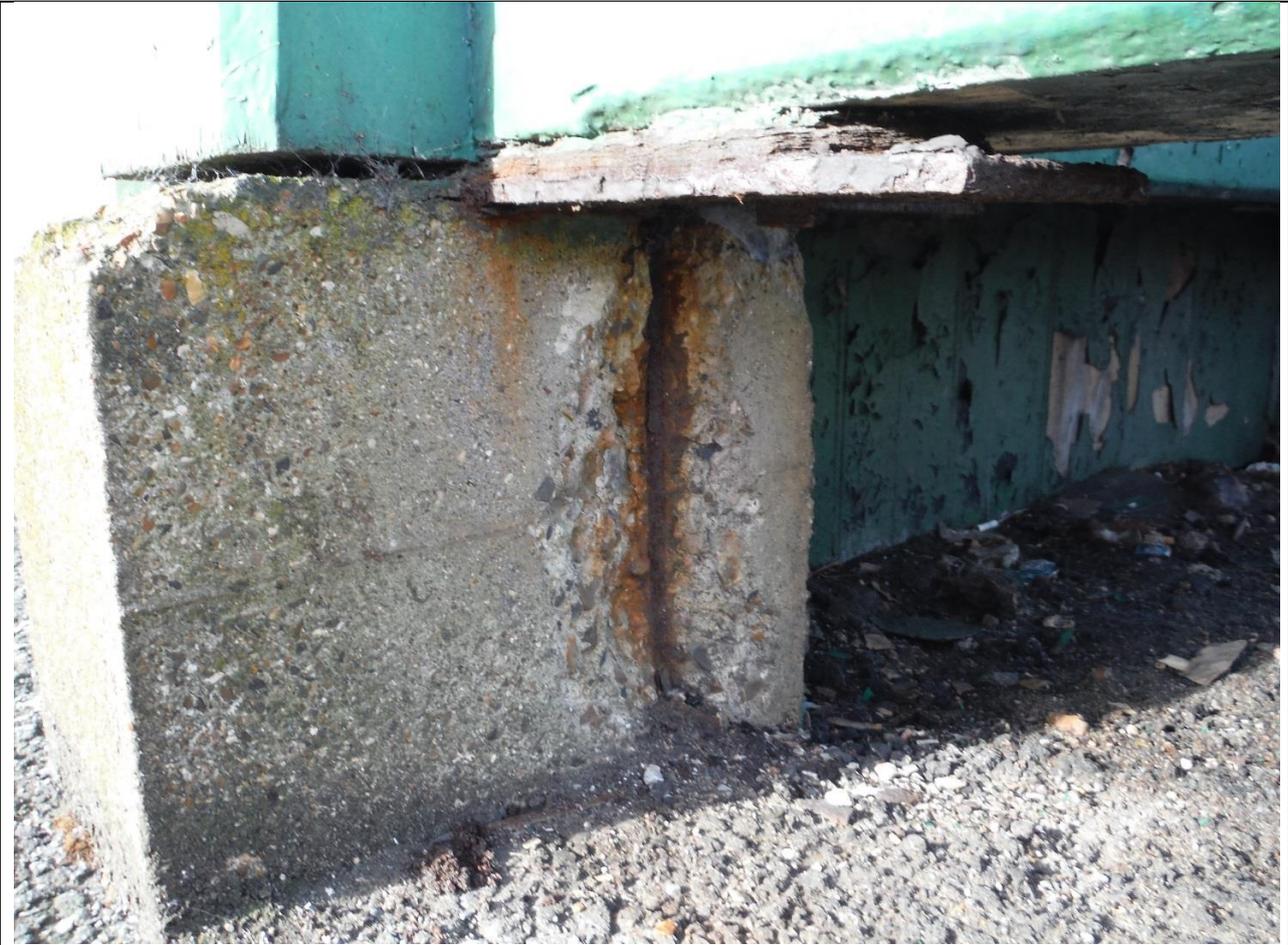
Photo 4: Minor spalling and corrosion of reinforcement at southernmost of 4 post column concrete base support (Platform 1)

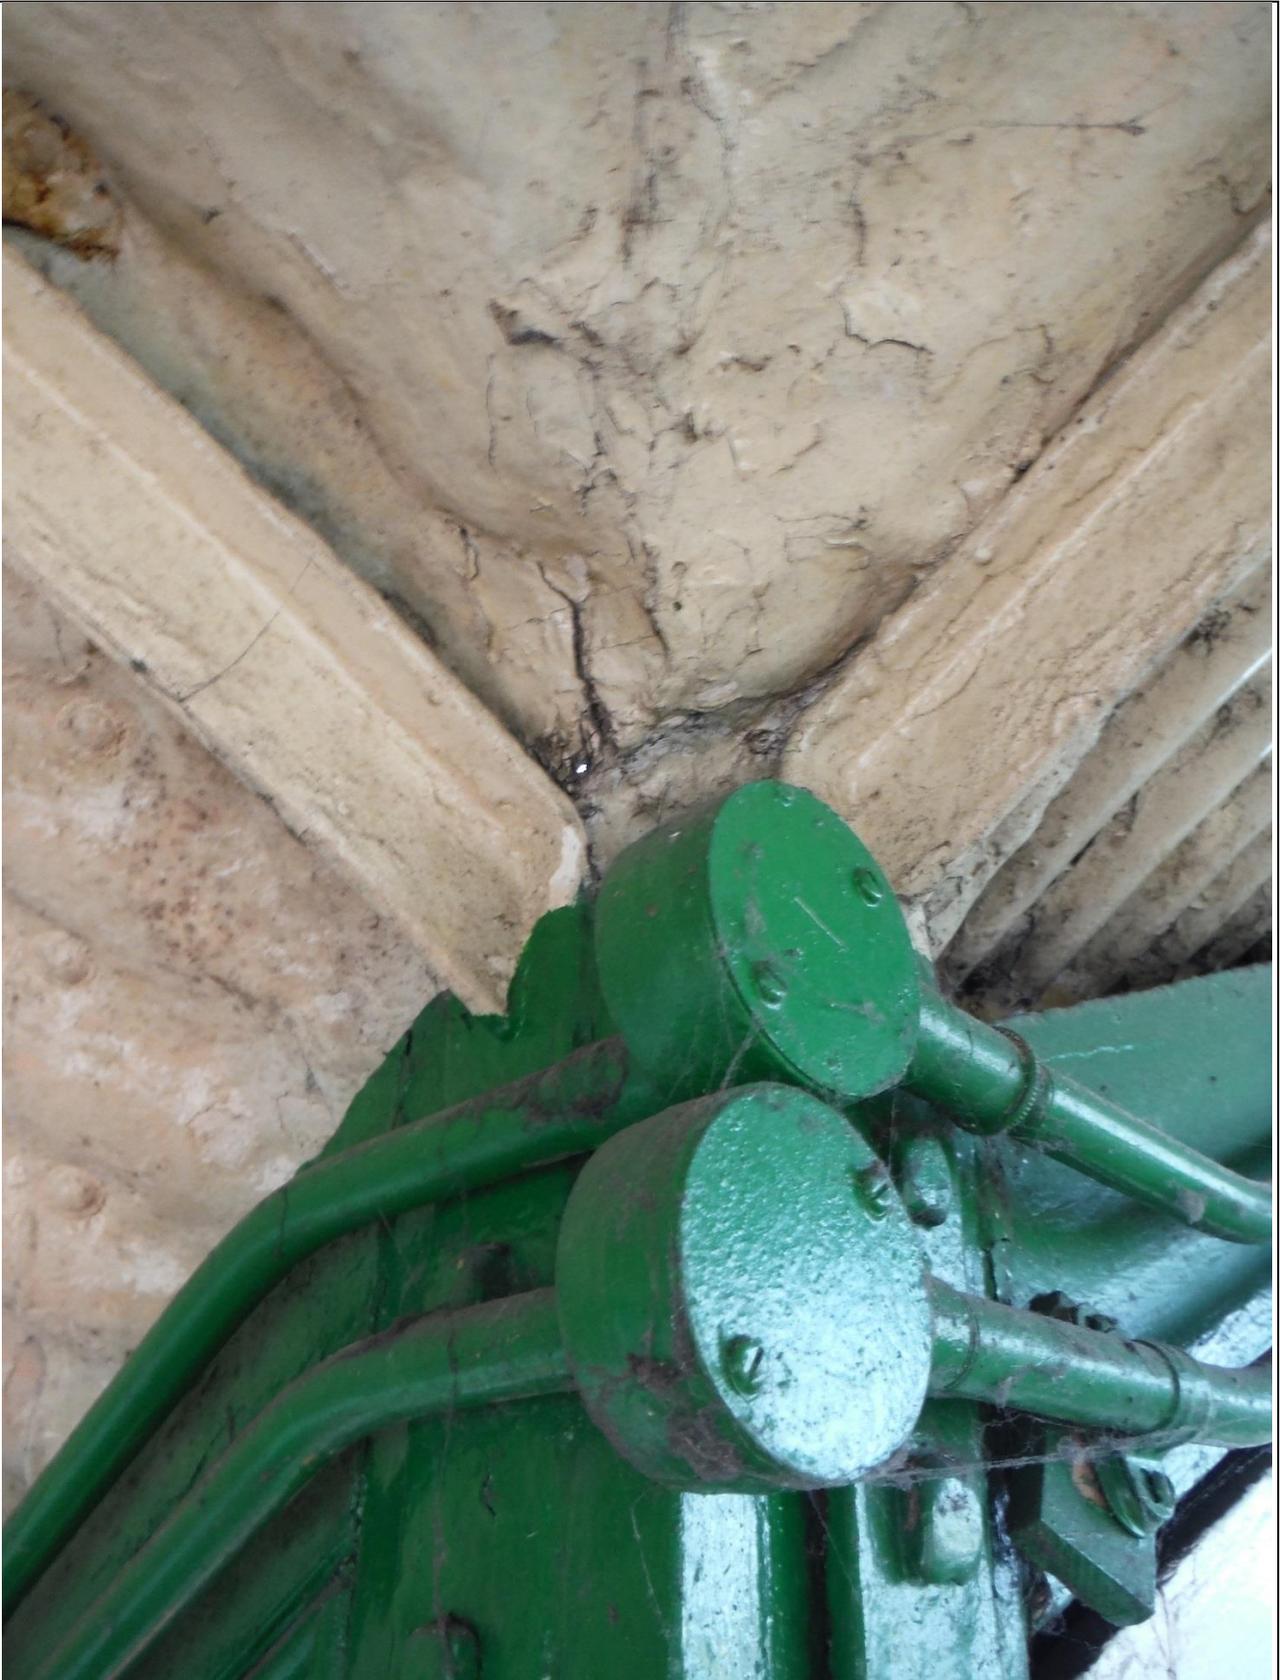
Photo 5: Split in corrugated roof cladding at stair landing, causing leak into footbridge and water ingress at westernmost corner (Platform 2)

5	Crack and hole in corrugated roofing causing leak into the footbridge and water ingress at corner location	Repair crack and hole in roof cladding or replace defective corrugated element. Repair timeframe to be aligned with timber repair to ensure the structure is watertight prior to treatment of areas affected by rot.	3 Months
6	Swelling of wood causing separation at corner location	No immediate action Area to be monitored at regular maintenance intervals	N/A
7	Wet rot causing loss of section	It is recommended that where rot (wet and dry) is present that specialist advice is sought to ensure appropriate remedial action is taken to agree a surface treatment is performed to prevent further section loss	3 Months
8 & 9	Wet rot causing loss of section	It is recommended that where rot (wet and dry) is present that specialist advice is sought to ensure appropriate remedial action is taken to agree a surface treatment is performed to prevent further section loss	3 Months

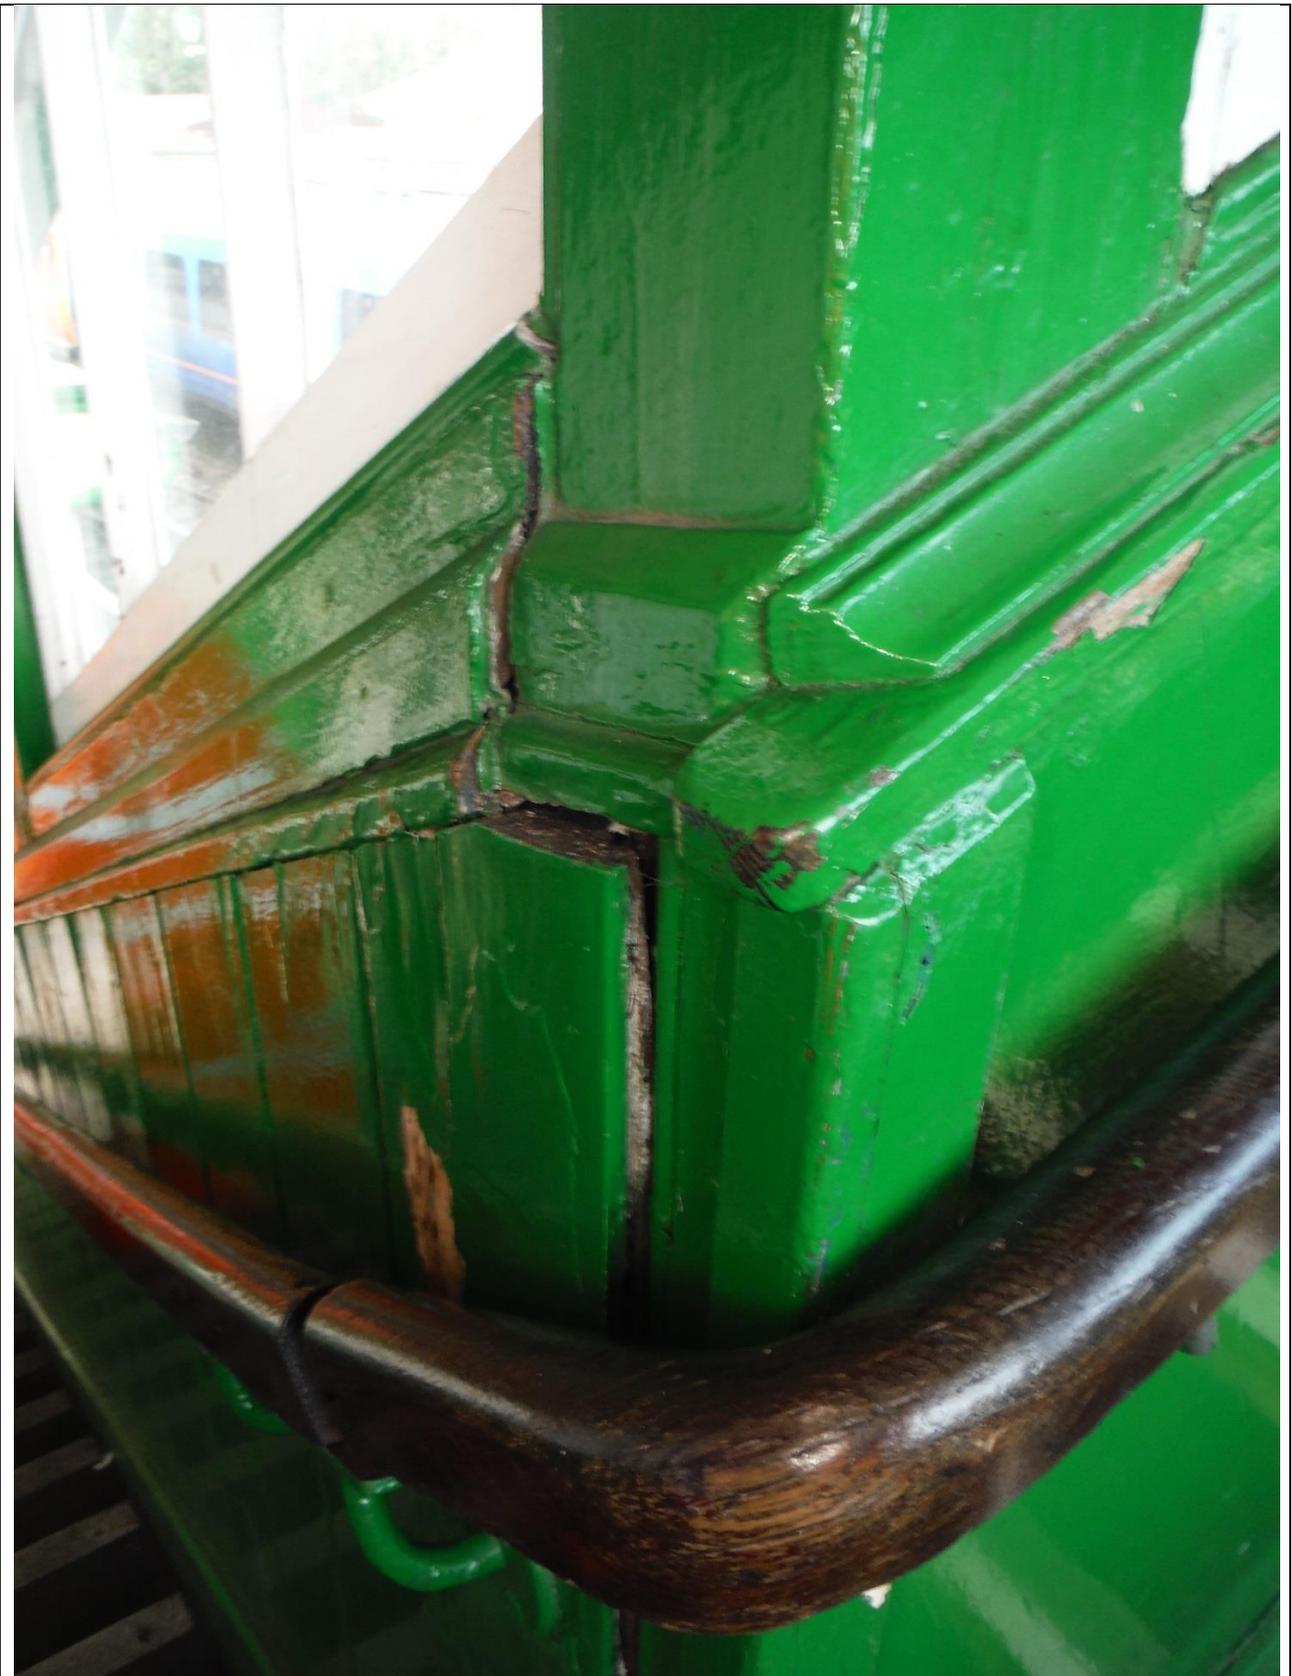
Photo 6: Roof leak above causing swelling and separation of stair corner joint (Platform 2)

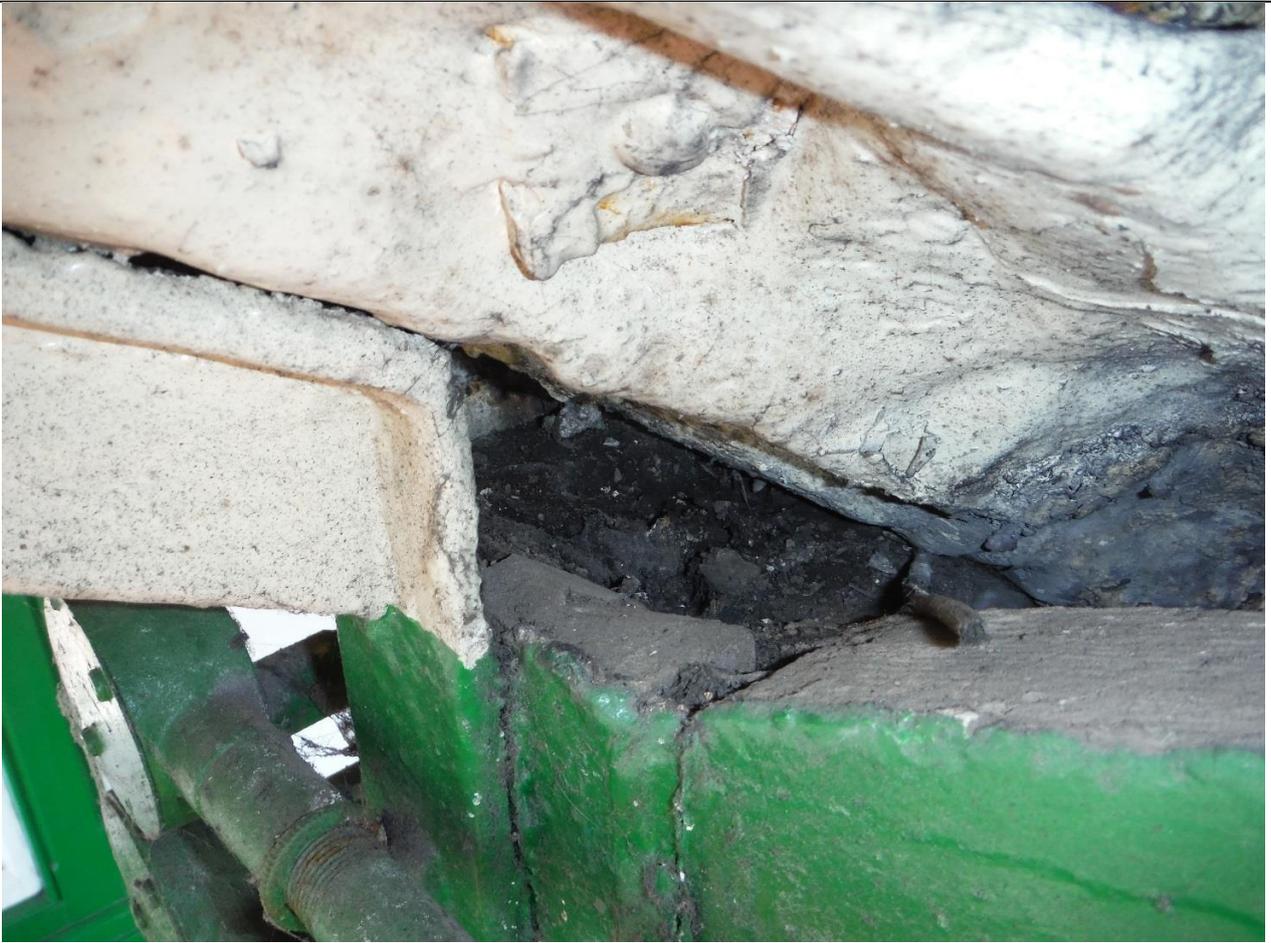
Photo 7: Wet rot to top of vertical roof support timber directly below leak (Platform 2)

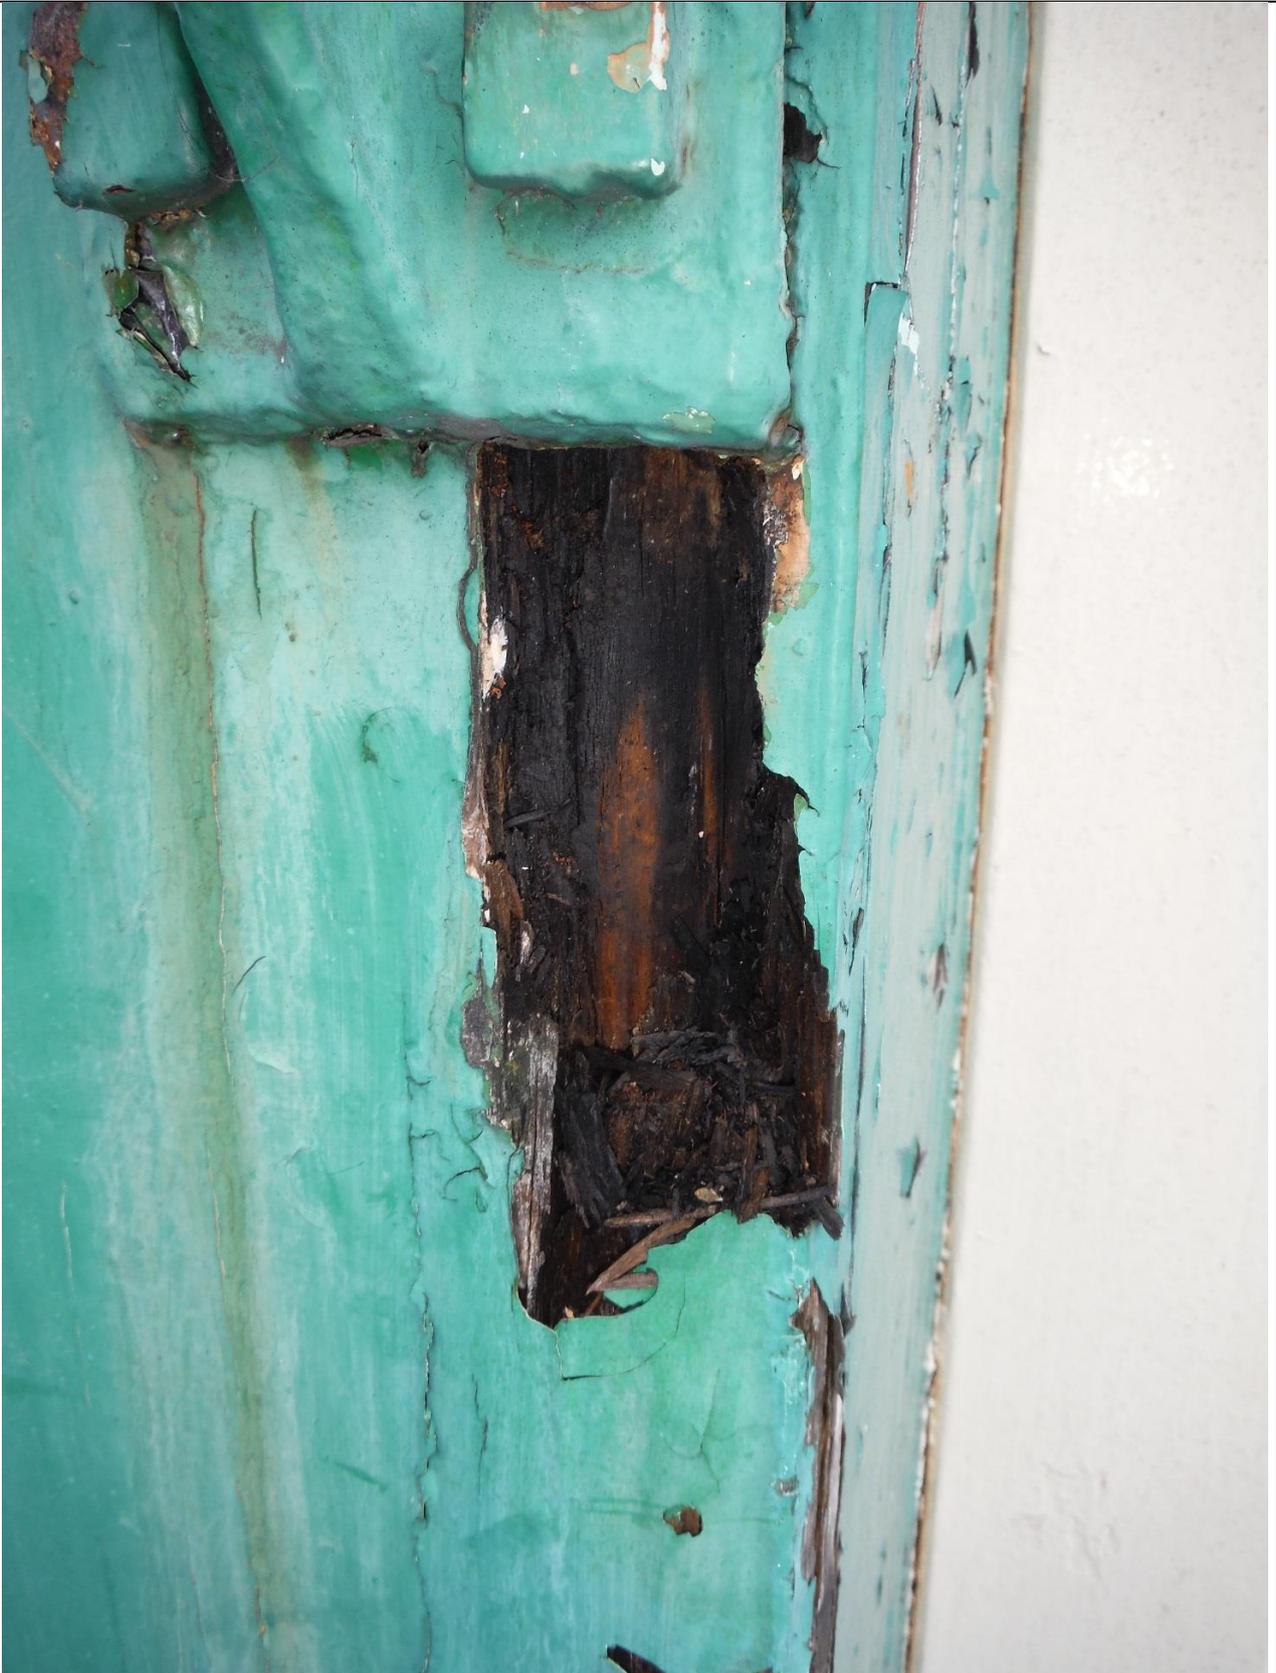
Photo 8: Wet rot of timber at steel T-section connection at westernmost corner directly below roof leak (Platform 2)

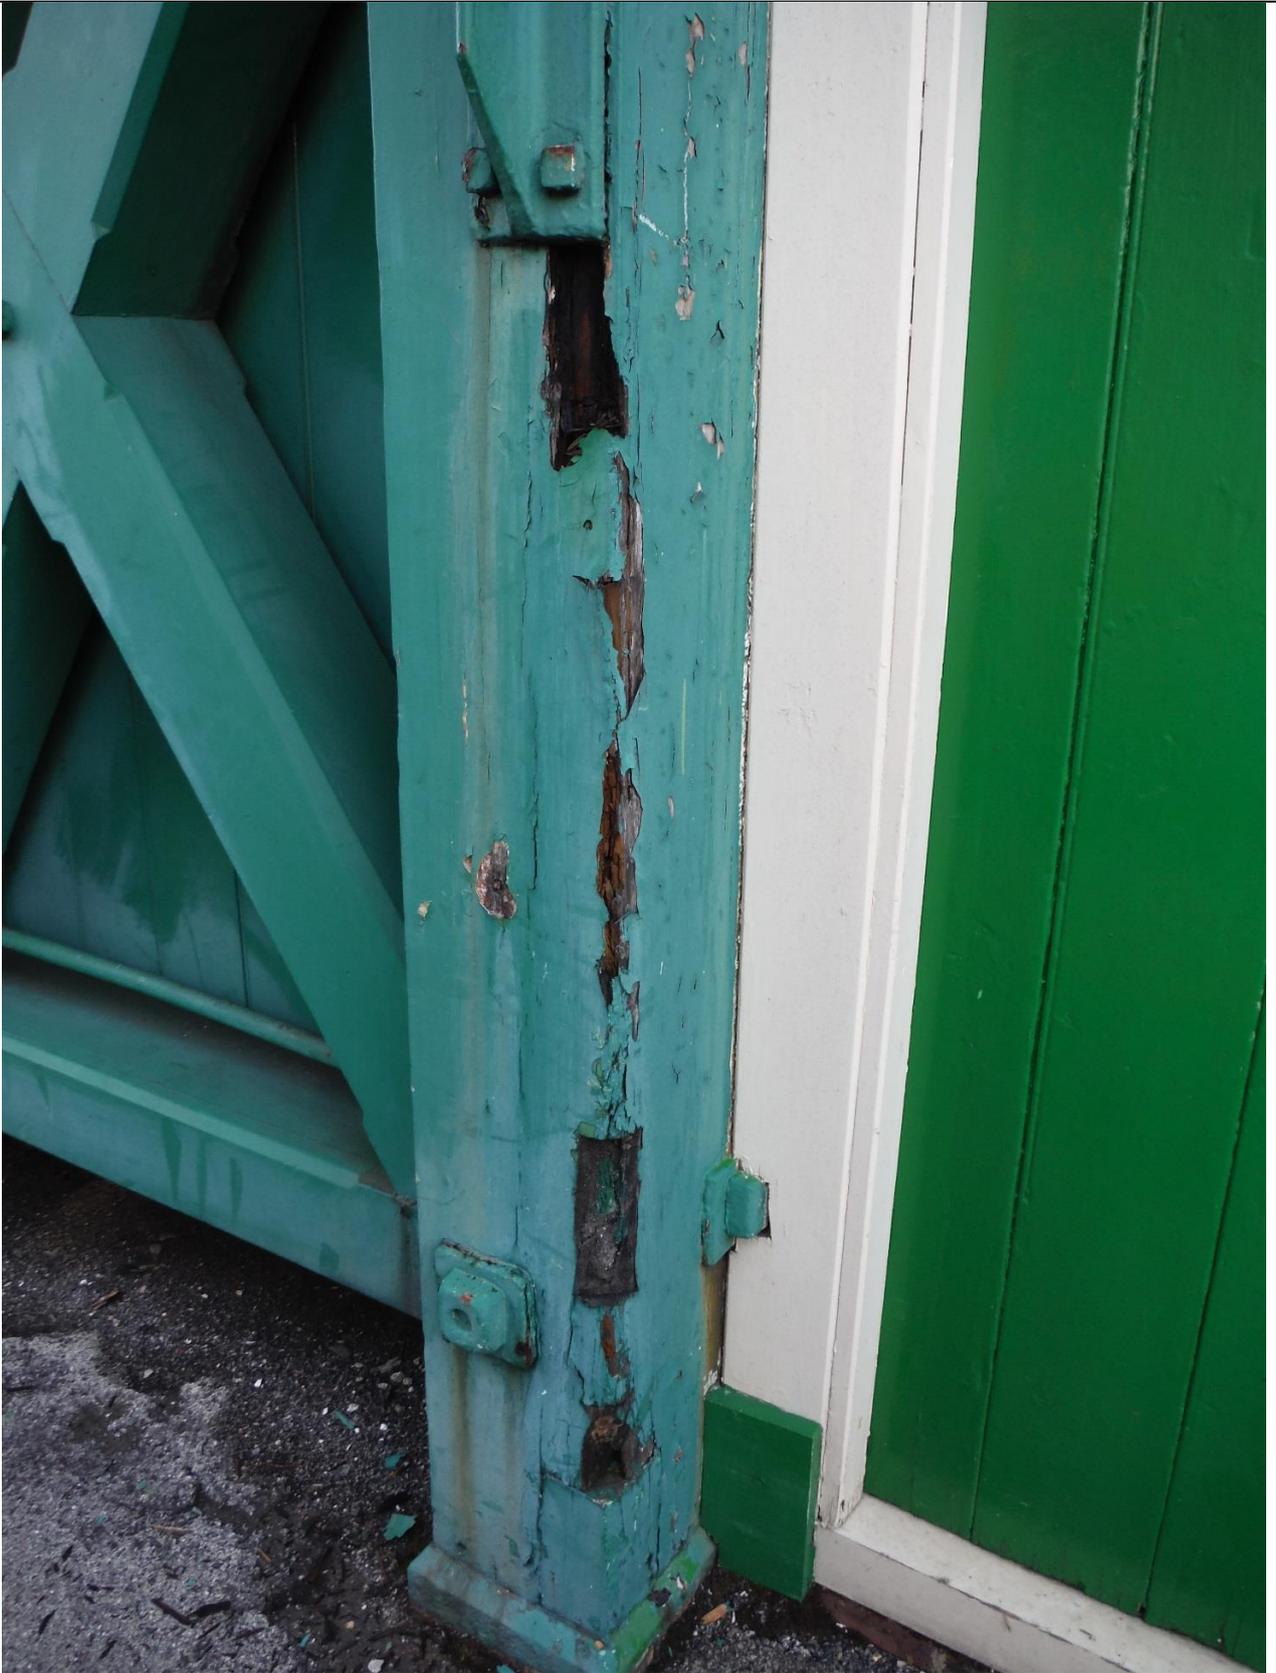
Photo 9: Wet rot of timber at steel T-section connection at westernmost corner directly below roof leak (Platform 2)

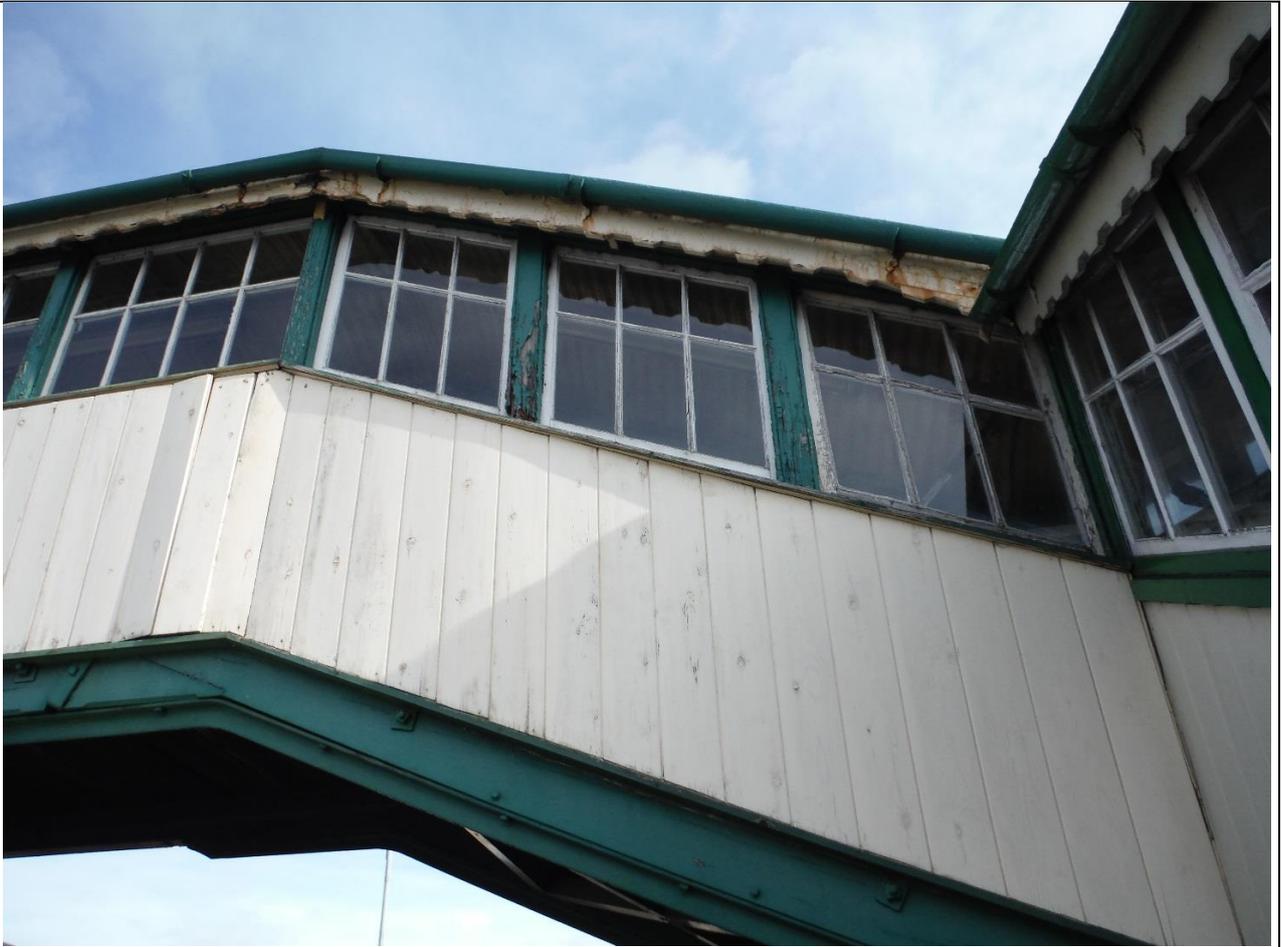
Photo 10: leaking gutter allowing water to spill onto country end face of the footbridge causing paint to peel and degrade timbers (Platform 2)

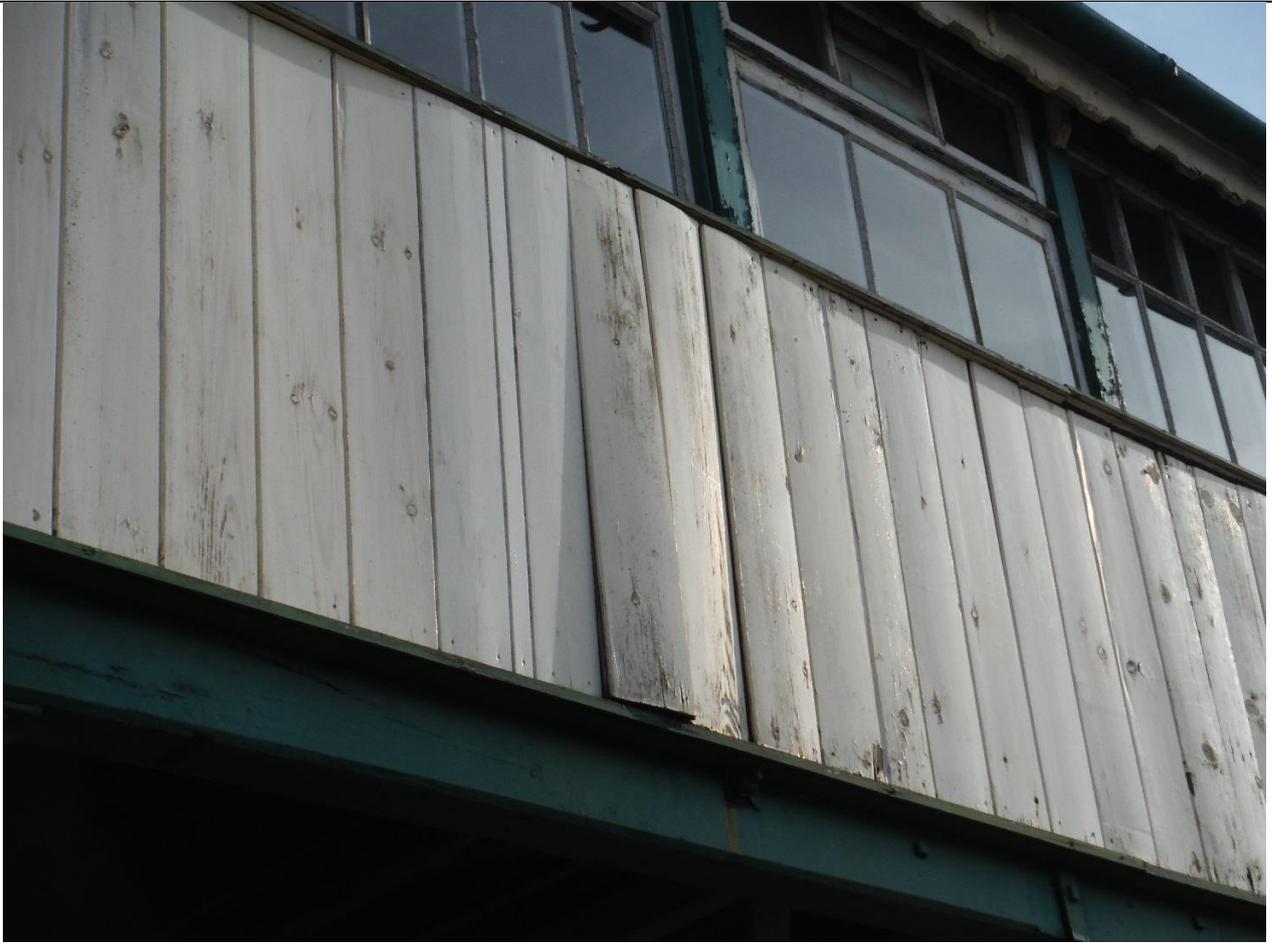
Photo 11: Swelling of timber cladding caused by rainfall. Cladding requires refixing to ensure it does not become dislodged in high winds (Platform 1)

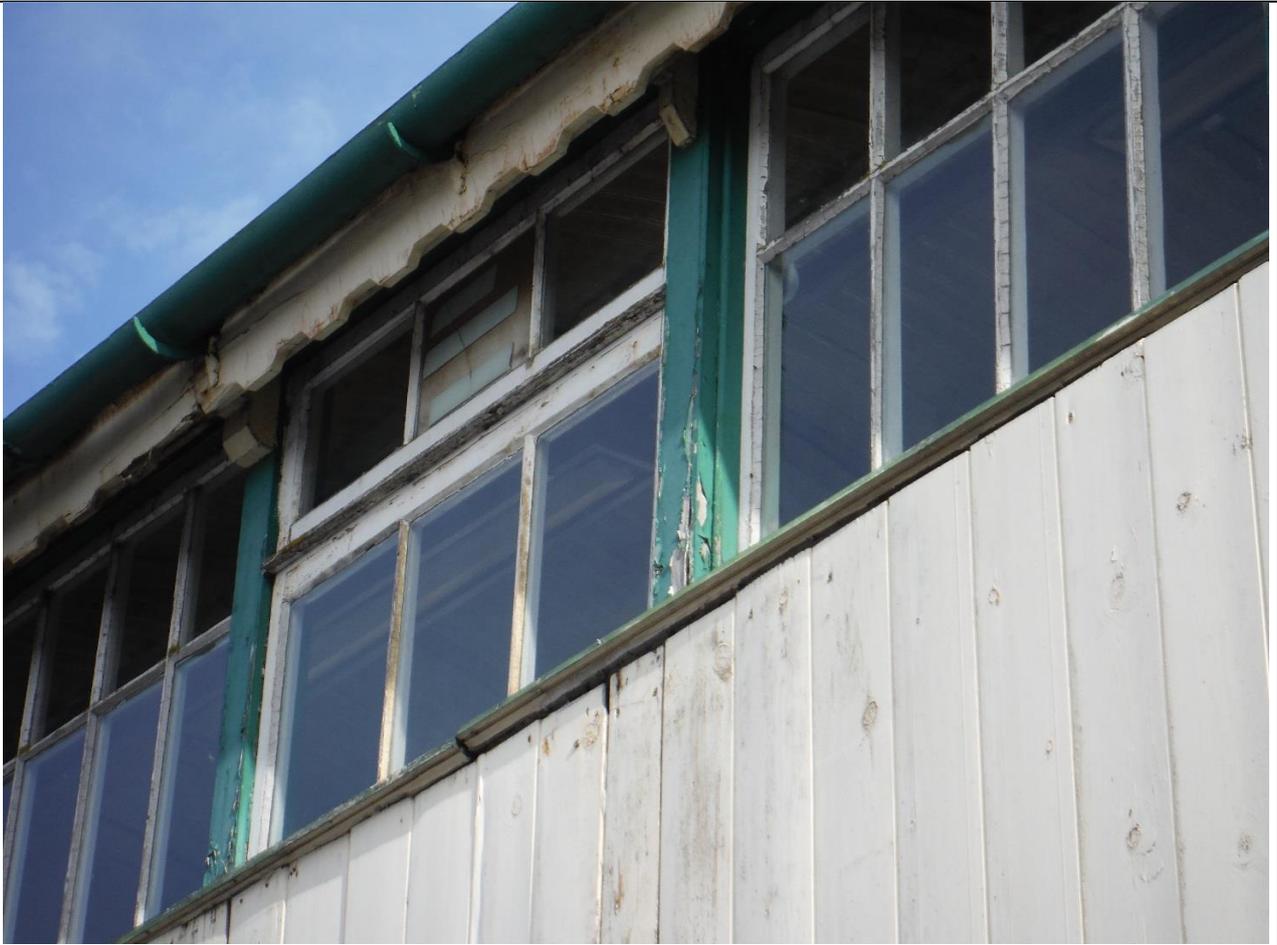
Photo 12: Broken glazing pane in the centre glazing panel above the line. Replacement and repair required

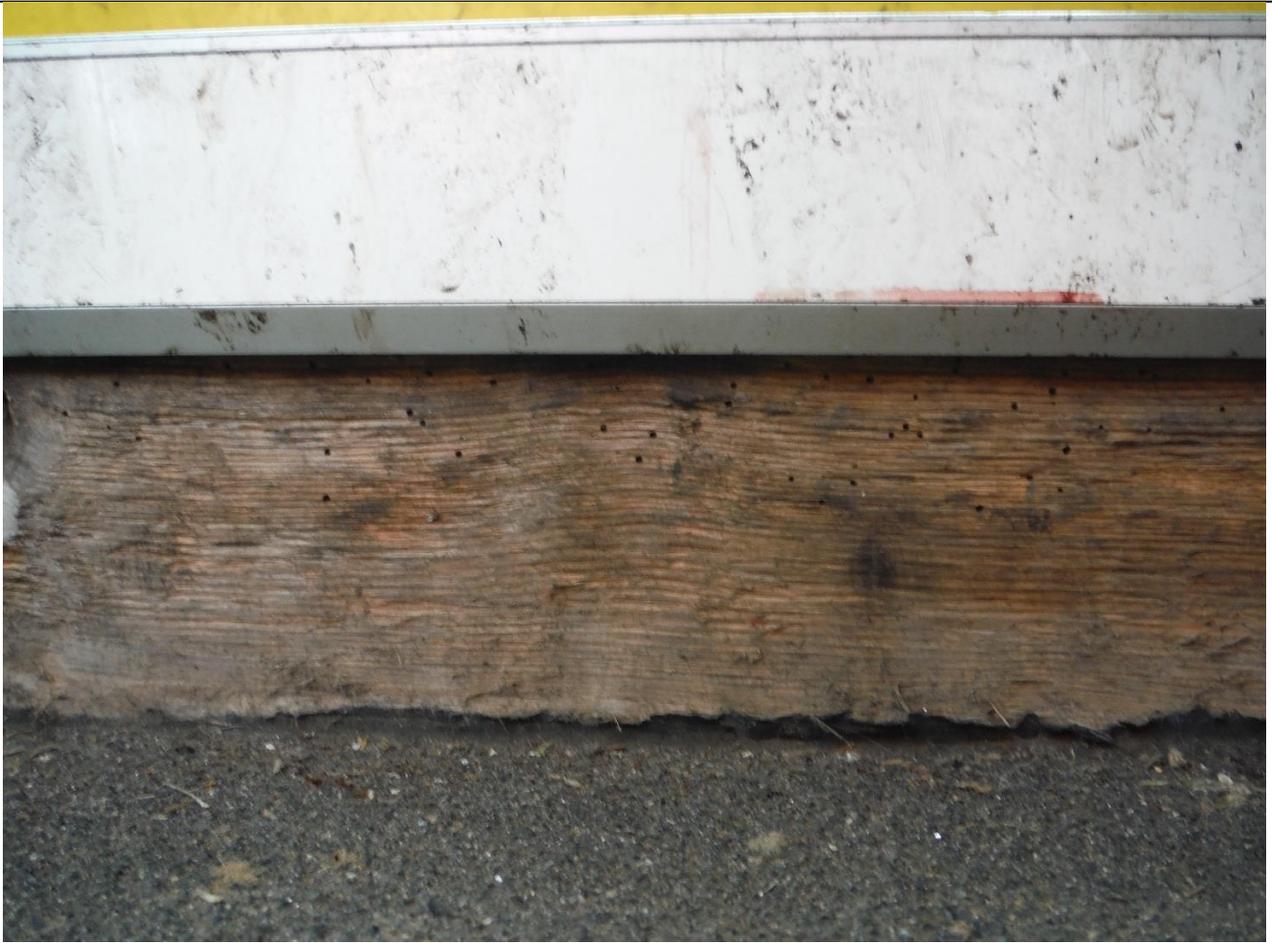
Photo 13: Woodworm affected stair risers (Platform 1)
