Alton Station Timber Footbridge

Structure Summary Report January 2017

Date 09 April 2015
Reference UA007705-19-ECV-MEM-HYD-1502 rev A01
From Toby Skeels
To Ian Grimes, Daniel Perez
Copies Richard Shimell, James Buckley, Tom Faith, Geoff Rowan
Subject Alton Station – Heritage Footbridge Condition Report

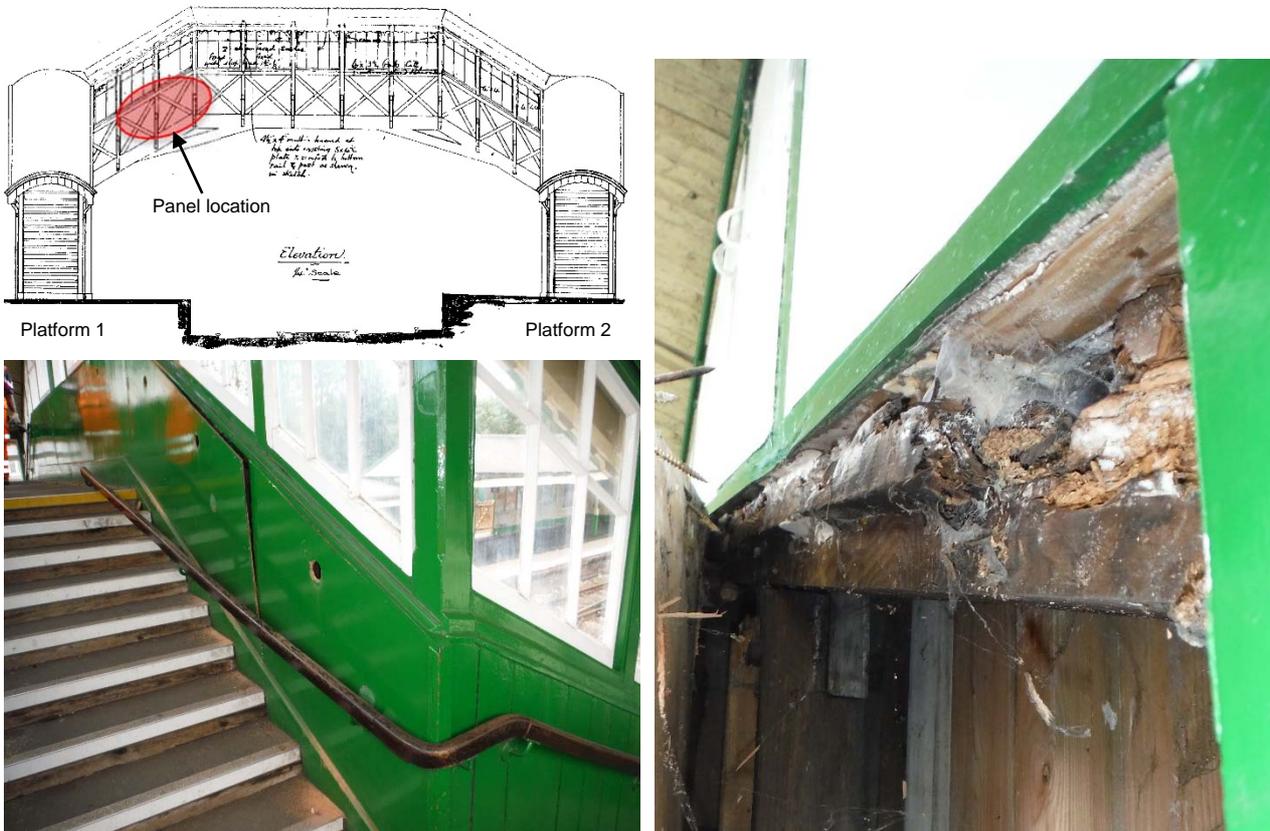
Hyder engineers conducted a daytime site visit on 30 July 2015, principally to look behind the panel Sumo opened adjacent to the Platform 1 stairs. The panel had a significantly rotten timber member, spanning between vertical members beneath the window sill. This location is shown in Figure 1.

Figure 1: Location and rotten timber behind internal panel

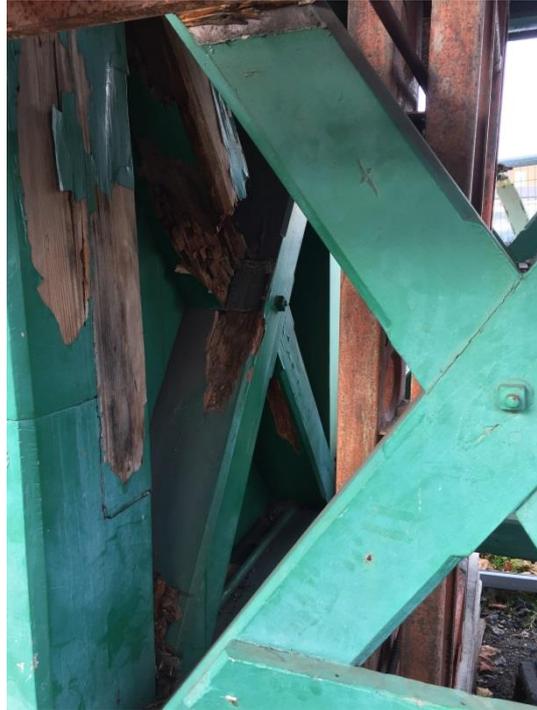
- The trestle supports have obviously suffered significant decay as a result of water ingress causing loss of section in trestle members on both sides of the bridge. Significant repair or member replacement is required to both trestles.

Fig. 3 Decayed trestle timbers

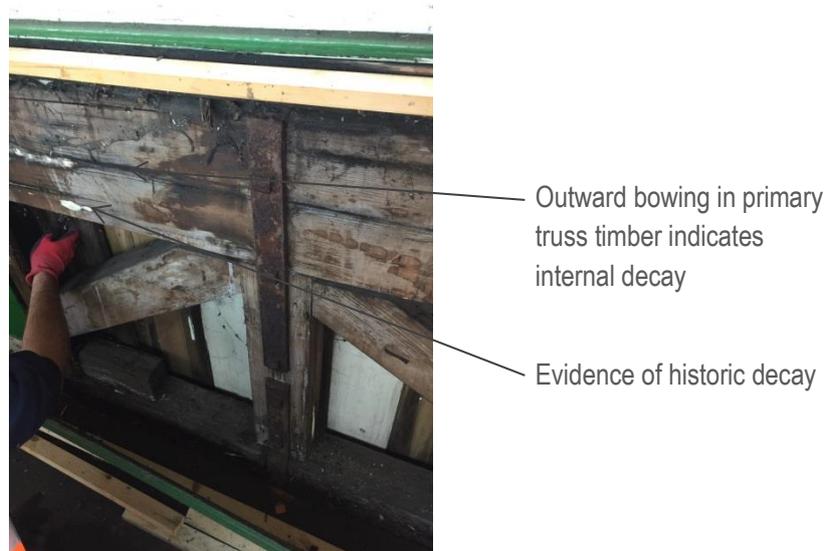
- The primary timber truss members of the south truss were exposed by removing the internal boarding. The truss appeared damp and signs of wet rot both historic and existing were visible. Some loss of section was observed although the moisture content of all primary timbers was less than 20%. (Moisture contents of greater than 20% are generally required for decay to occur.) Although some decay has obviously taken place the primary timbers appear to be largely sound where exposed.

Fig. 6 Primary timber truss exposed

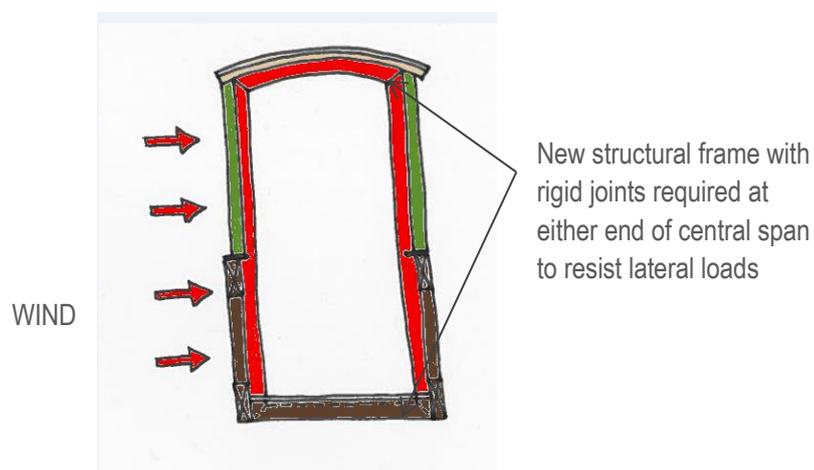
It should be stressed that this analysis takes in to account vertical load only and no complex three dimensional of dynamic effects have been considered. In this situation it is likely that wind loading will be the critical load case and the slender trusses have very limited capacity to resist this load. Significant strengthening in the form of additional structural members is likely to be required to resist lateral loads.

Fig.9 Strengthening required to resist lateral loads
