Alton Station Timber Footbridge

Structure Summary Report January 2017

Date 09 April 2015
Reference UA007705-19-ECV-MEM-HYD-1502 rev A01
From Toby Skeels
To Ian Grimes, Daniel Perez
Copies Richard Shimell, James Buckley, Tom Faith, Geoff Rowan
Subject Alton Station – Heritage Footbridge Condition Report

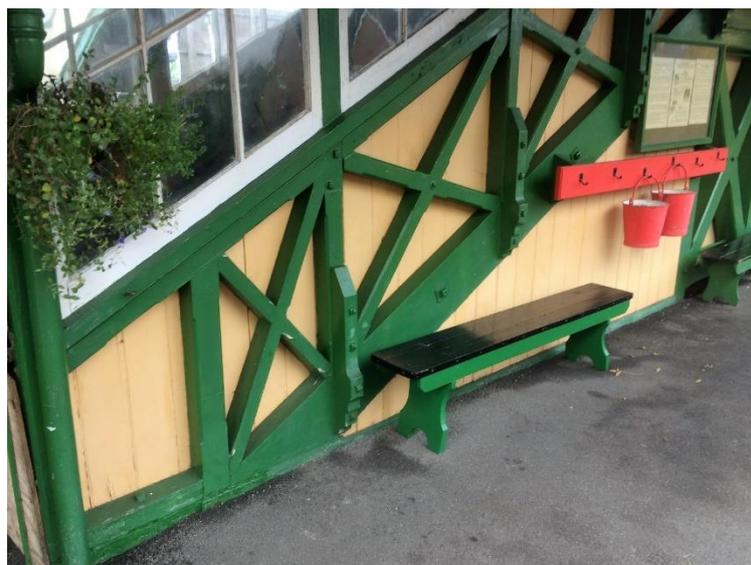
Figure 4 – Alton station footbridge stair elevation on platform 3 showing original bracing.

The 'open' footbridge at Alton station was not popular with ladies; they successfully lobbied the LSWR to have the bridge covered and the open sides boarded over in 1894. Clearly they were not satisfied with this because the bridge was fully enclosed with windows in 1896. Although this is pretty much the form we see today, at some point match-boarding was applied to the outside of the bridge elevations where previously it had only been clad inside the cross-bracing. This former arrangement is seen on the side of the bridge exposed on platform 3 adjacent to the Mid Hants Railway (see figure 4).

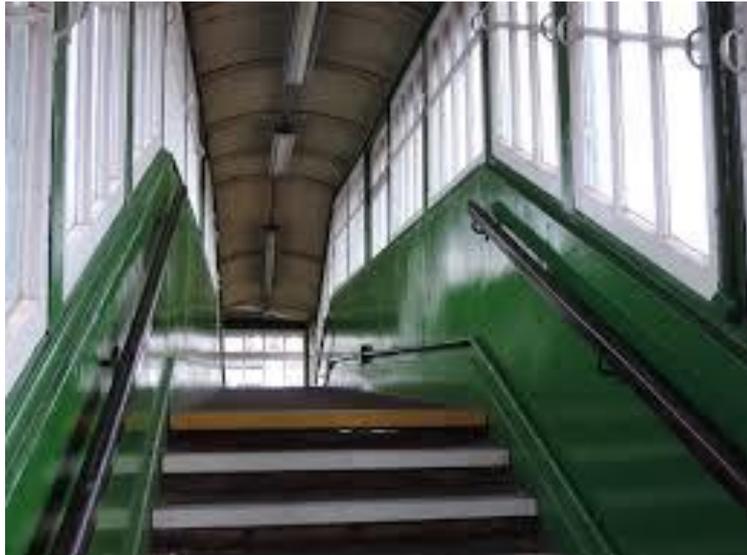
Figure 5 - Photo of footbridge interior

The corrugated sheet roof covering and associated light metal frame is supported on timber posts integrated with the underlying timber truss. The subsequent glazing was fitted between the posts supporting the roof and additional window mullions (see figure 5).

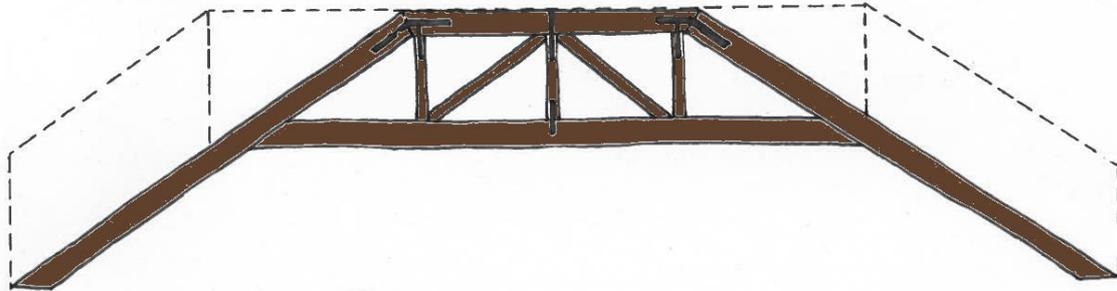
Figure 7 – 'A' shape Howe truss

The principal underlying structural form of the footbridge is two 'A' shape timber 'Howe' trusses (see figure 7) with a braced timber deck/walkway spanning between the two trusses. The main span is approximately 11.5 metres between the two timber trestle supports.

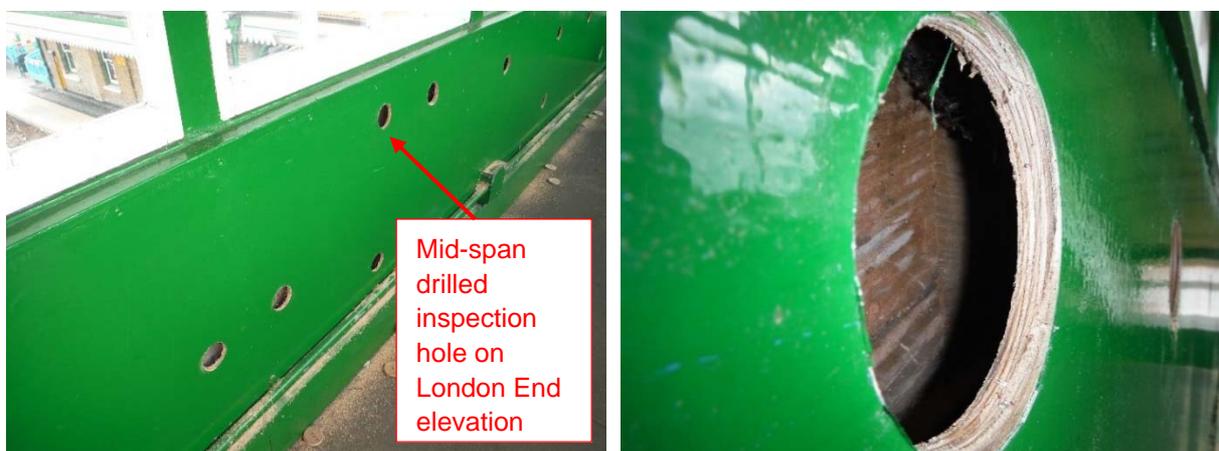
Figure 2: Drilled inspection hole showing diagonal member transition into horizontal member

The visual survey continued by looking through the drilled inspection holes on the internal cladding panels to attempt to determine the bridge structure, as initial findings suggested differences to archive information, such as an absence of the cross bracing beneath the windows (as shown in the archive drawing displayed in Figure 1). Whilst the location and size of the holes limited the extent of information to be gained, no cross bracing was observed behind any panel and some structural form could be identified, including perceived main diagonal and horizontal elements, as illustrated in Figure 2 (and shown further in Figure 15).

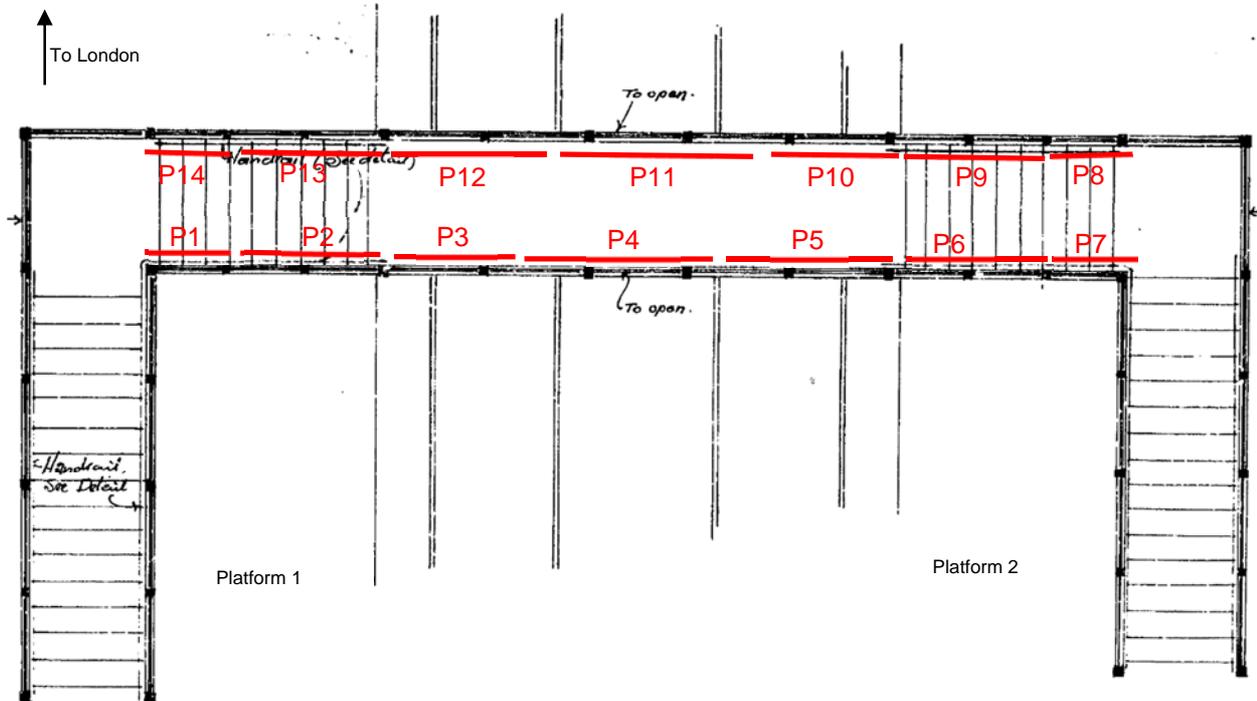
Figure 3: Internal panels numbering for video survey

The video did not provide sufficient lighting levels or image quality to determine any additional rot within the main span. No timbers with section loss were identified and it is unclear if the timbers were wet or dry at the time of filming.

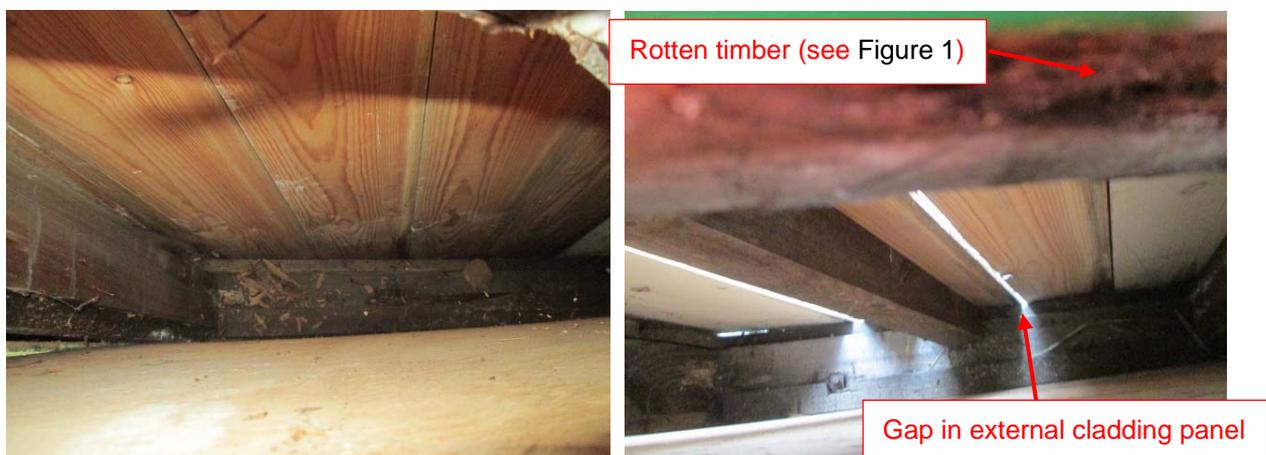
Figure 4: View down into Panel 1 and view down into Panel 2

The photos behind the panels illustrated evidence of water ingress, such as discolouration and damage to window sills, and signs of some surface damage to members. From this evidence, these defects are judged to be non-structural and no significant rot within the main span has been identified. However no touching inspection has been performed and unclear if the timbers were wet or dry, soft or hard. Gaps to external cladding panels were previously identified and panels should be re-fixed as required.

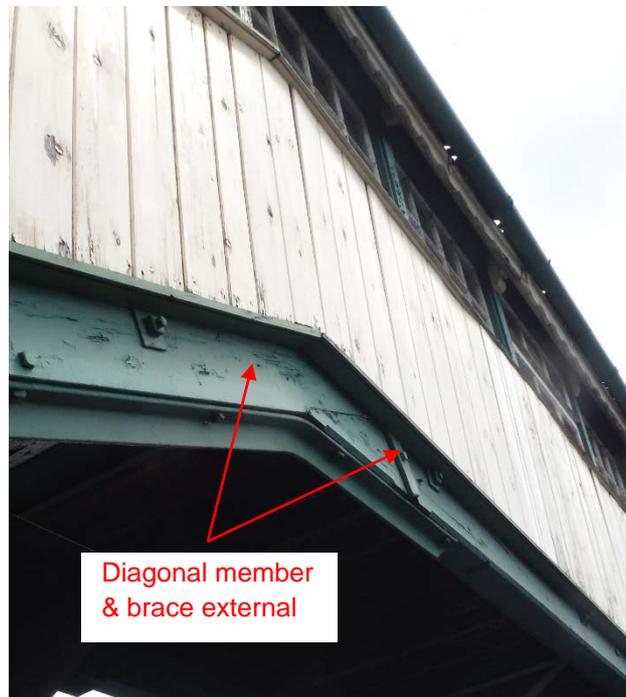
The video and photographic evidence provided shows the diagonal members (transverse stair stringers) spanning from the support trestles do not form the bottom chord of the footbridge. These diagonal members continue up into the structure and another member spans horizontally across the tracks. This supports external observations and suggests metal bracing has been used to provide a link between these two structural members.

Figure 14: View from Platform 1 of external main span diagonal member which continues under the stairs up between the internal panels and external cladding. A metal brace appears to pass above this diagonal member, as shown in Figure 5 and Figure 10 and fix externally into the main horizontal member

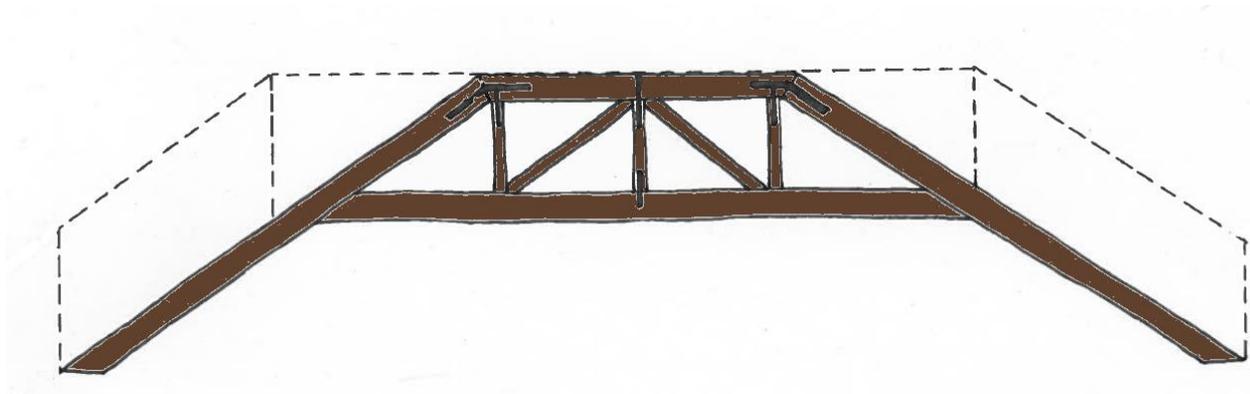
Fig. 1 Bridge truss as built

The bridge spans approximately 11.5m over the railway at Alton Station and is constructed from two primary timber trusses, one to each side of the walkway. The primary truss members are connected using iron or steel plates and straps. The walkway is braced on plan and the trusses are supported on timber trestles which sit on the platforms to either side of the line. The primary trusses are built in to the balustrades to either side of the walkway and covered with timber boarding externally and plywood internally. The top of the truss which forms the balustrade to the centre of the span is approximately 950mm above the walkway. The bridge is covered with what appears to be a corrugated iron roof spanning between slender steel or iron 'T' sections which are supported on timber window mullions fixed directly to the top of the balustrade.

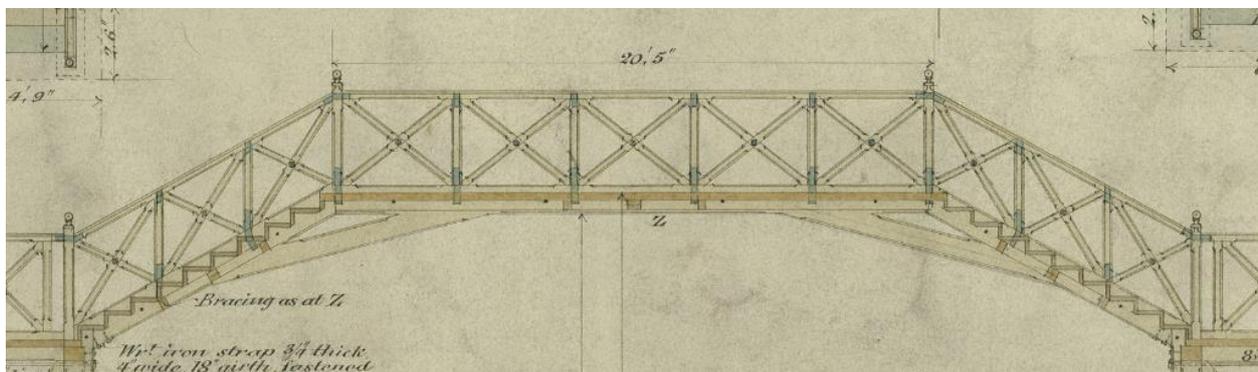
Fig. 2 Bridge truss as shown on historic drawings

Historic drawings of the bridge exist but they do not reflect the construction of the existing structure. The drawings show an exposed timber modified Howe truss. The design appears to have been modified prior to construction to allow the primary diagonal timbers to continue to the top chord. The side panelling and iron roof covering was subsequently added followed by the glazing.

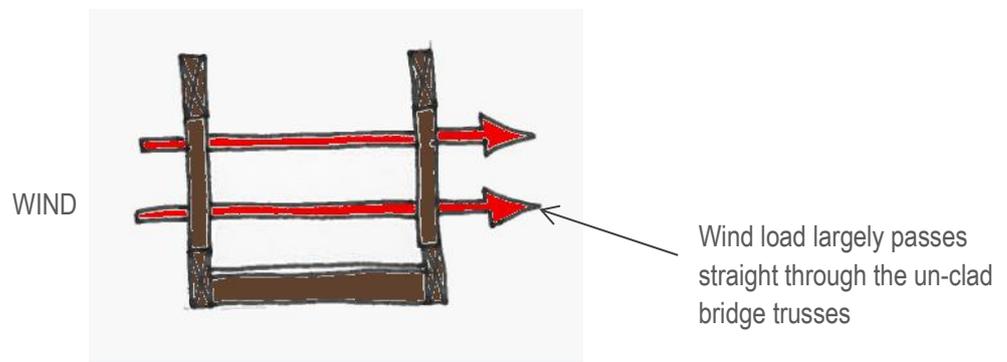
Fig. 4 Original truss design

- The majority of the primary structure remains hidden beneath internal and external timber panelling. There is evidence throughout the structure that the primary structural members have decayed from the inside out leaving a shell of visually intact timber. This is potentially dangerous as without an extensive timber survey involving probing of each individual timber at regular intervals the extent of decay cannot be confirmed. Timbers may appear sound but actually have no structural capacity at all.
- The bridge has limited lateral stability parallel to the railway line and horizontal movement can be felt under very low loads. As the bridge appears to have been designed without panelling it is likely that it was never designed to carry a wind load. The bridge was subsequently covered and then enclosed with glazing and now attracts a significant lateral load parallel to the railway line.

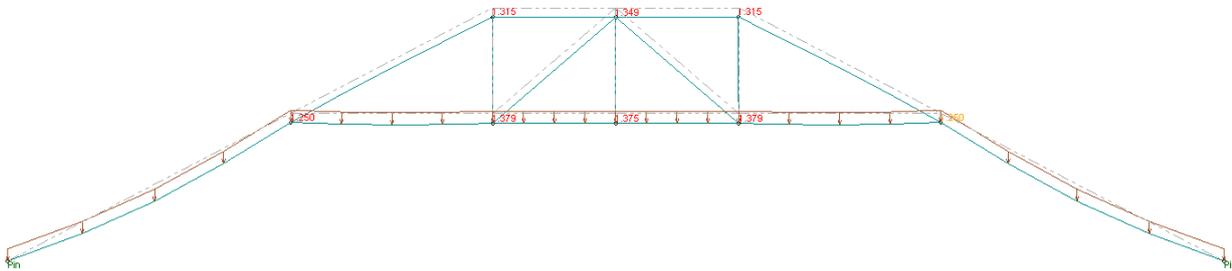
Fig. 7 Deflected shape of fully loaded bridge showing vertical deflections of less than 2mm

The analysis assumes that the truss timbers and all connections are in perfect condition and that the truss is prevented from spreading by the trestle legs. In reality this is unlikely to be the case.

The analysis shows that if in perfect condition the primary truss members would be strong enough to resist the self-weight and live load applied without significant vertical deflection.

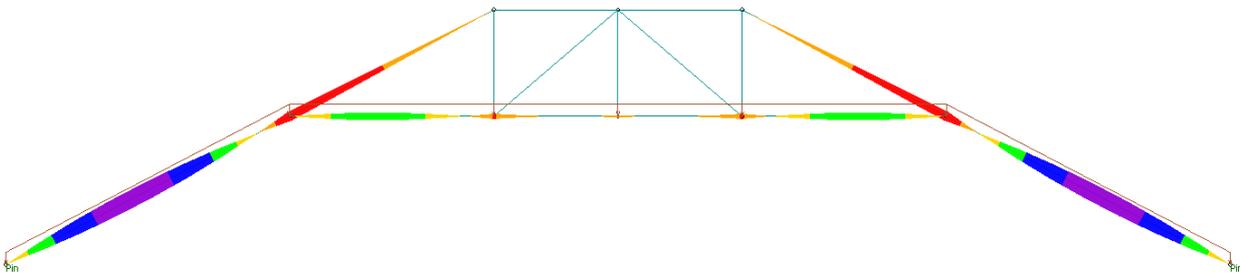
Fig. 8 Fully loaded model showing locations of maximum bending moments

It should be stressed that this analysis takes in to account vertical load only and no complex three dimensional of dynamic effects have been considered. In this situation it is likely that wind loading will be the critical load case and the slender trusses have very limited capacity to resist this load. Significant strengthening in the form of additional structural members is likely to be required to resist lateral loads.
